Management of Combined Seismic and Energy Retrofitting of a Typical Swiss Building

Master's Thesis

Institute of Structural Engineering (IBK)

Swiss Federal Institute of Technology (ETH Zürich)

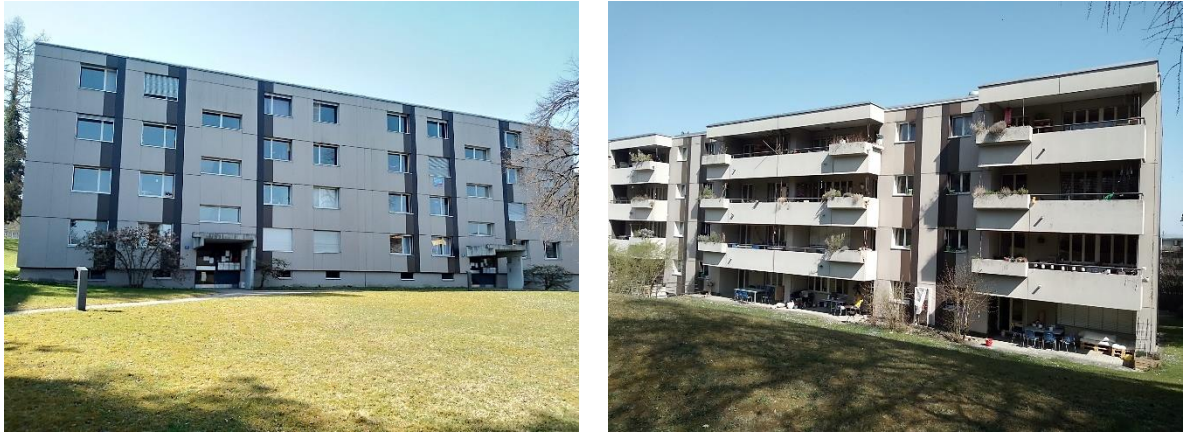
Figure 2: Eastern façade (left), western façade with balconies (right)

The complex was built in the early 1970s and the façades underwent a renovation in 1986. A general impression of the building can be gained from Figure 2.

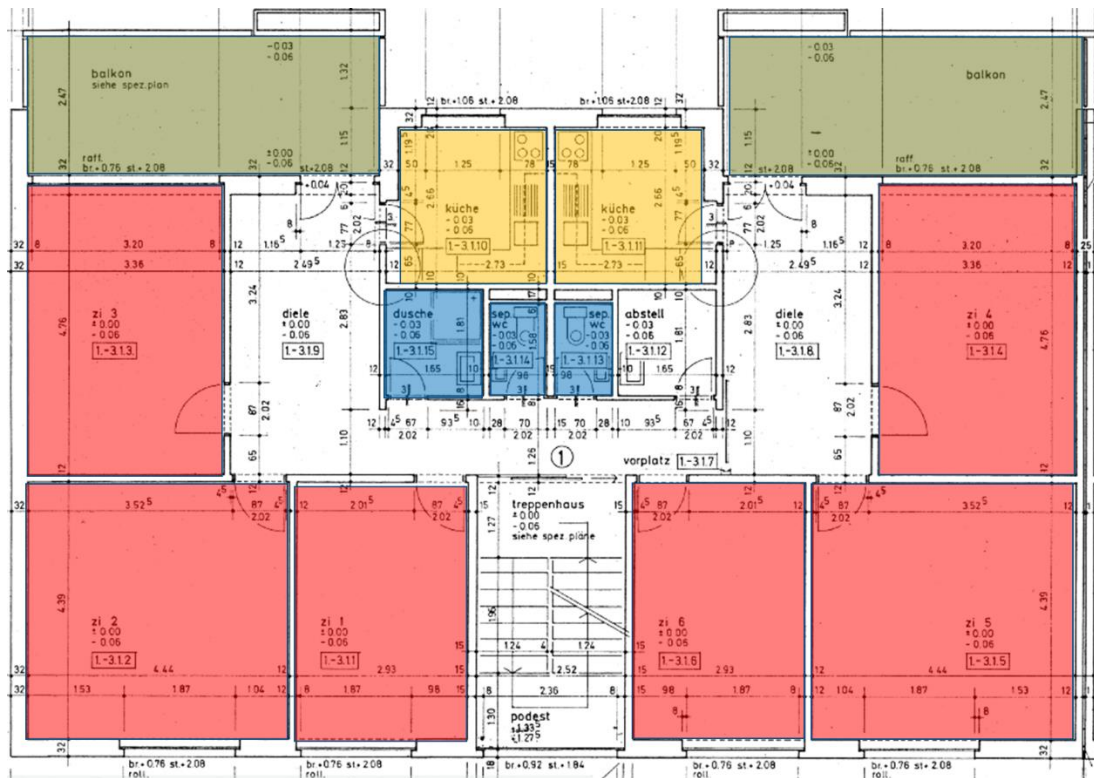
The layout dimensions are 18.25 m in length and 11.06 m in width. Each overground floor is identical and is subdivided into two residential units, each one of them comprising three rooms, a kitchen, a restroom and a balcony (Figure 4).

Figure 4: Layout of the upper floors

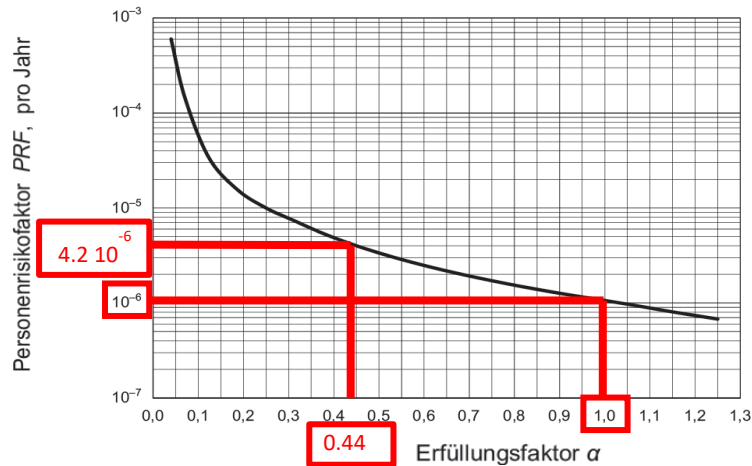
The comparison of costs caused by seismic retrofits with the therewith achieved risk reduction provides the base to assess commensurability defined by SIA 269/8: 2017 [1]. The lowest compliance factor α_{min} determined in Section 2.1.2 is used to quantify the personal risk factor (PRF) with the aid of Figure 6. Subsequently, the difference in PRF between the initial value of $\alpha_{min} = 0.44$ and a compliance factor $\alpha = 1$ required for new buildings is calculated.

Figure 6: Personal risk factor (PRF) as a function of the compliance factor α (SIA 269/8: 2017 [1], figure 7)

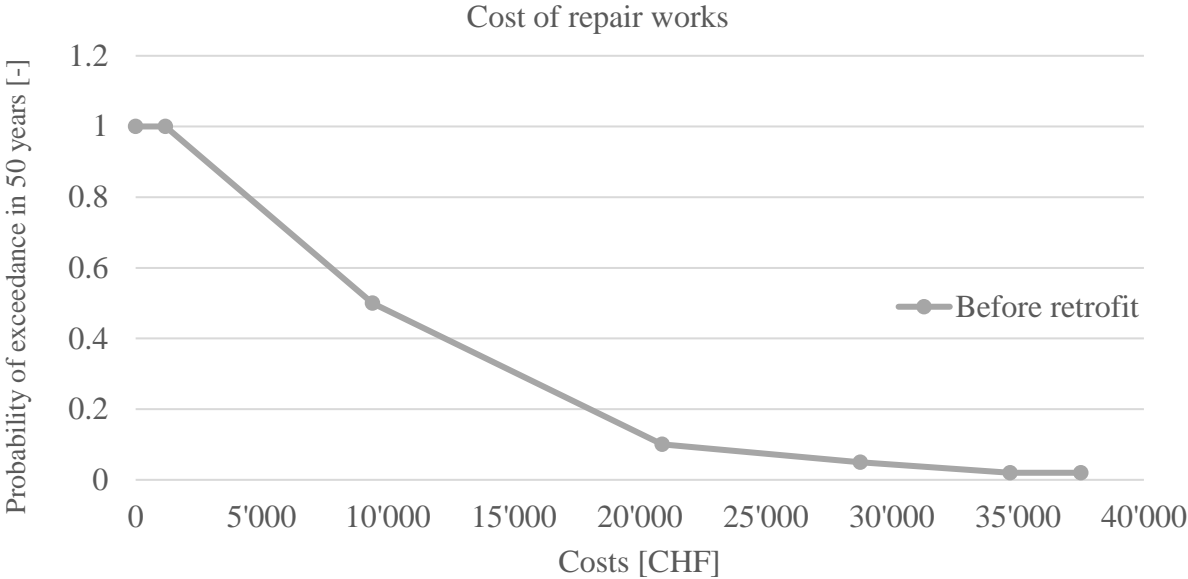
The probabilities of exceedance of seismic events (sourced from the EFEHR hazard maps [37]) causing given costs of repair/replacement works are plotted in Figure 11, while the detailed calculation of the walls' area to be repaired or replaced is given in Appendix A (Table 40).

Figure 11: Cost of probable repair works for different displacements and related probabilities of exceedance (loss function)

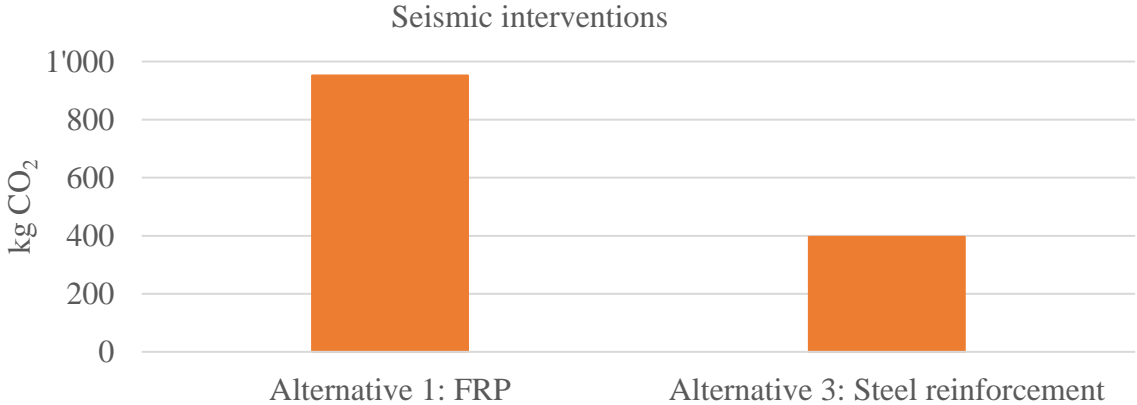
Figure 14 and Figure 15 depict the CO₂ emissions entailed by every considered retrofit option graphically. The greenhouse gas emissions per unit area shown in Table 16 are multiplied by the respective surface of application. It is assumed that the seismic interventions are executed on 30.8 m² of unreinforced masonry walls, while the thermal insulation is installed on all perimetral walls (547.8 m²), the complete roof gets an additional insulation layer (186.8 m²) and every window is substituted (76.7 m²). To remark is the fact, that only CO₂ emissions arising from the materials' production are represented in Figure 14 and Figure 15, while the amount of bound biogenous carbon in the organic materials is neglected in these diagrams.

Figure 14: Embodied CO₂ emissions in the seismic retrofit options [46], [70]

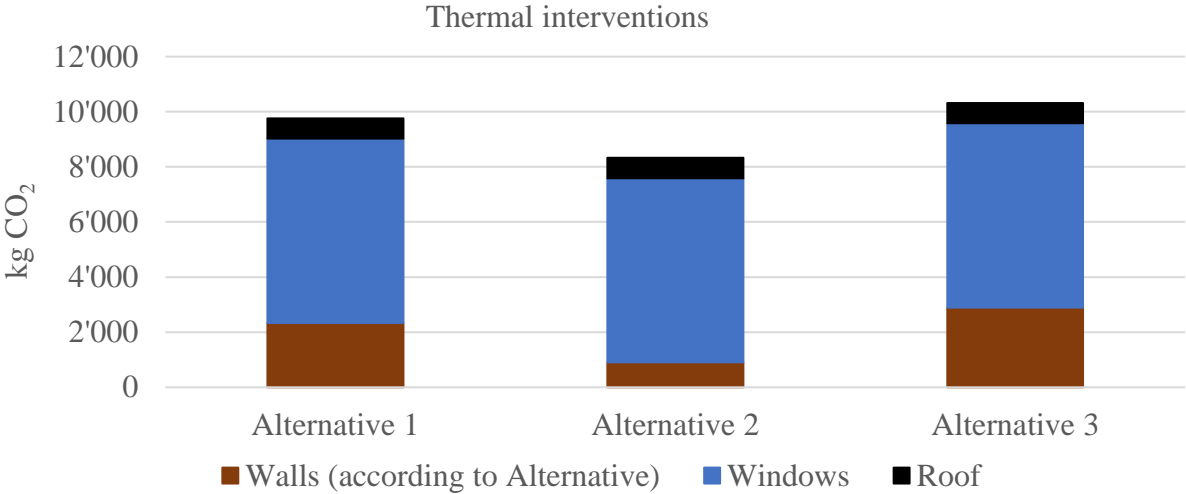
Figure 15: Embodied CO₂ emissions in the thermal retrofit options [46]

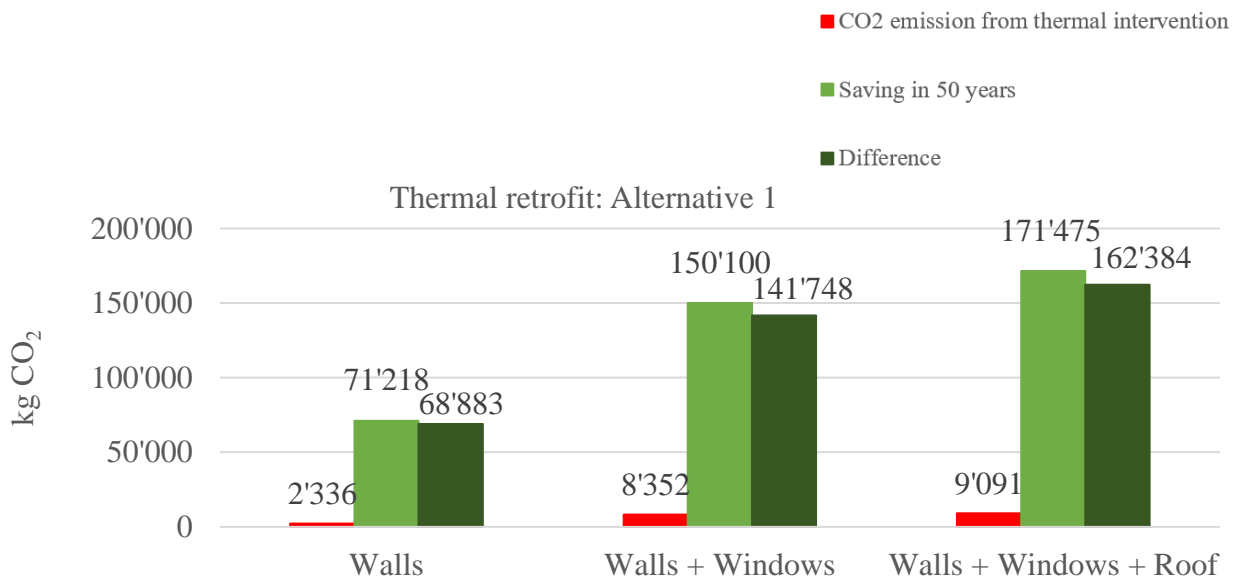
To compare the achieved emission savings from heating with the CO₂ invested for the production of the materials employed for thermal retrofit, graphical representations of the mentioned CO₂ balance over 50 years of remaining service life are given below (Figure 21, Figure 22 and Figure 23).

Figure 21: CO₂ emissions from thermal intervention (Alternative 1), savings from reduced heating demand and net savings of CO₂ emissions

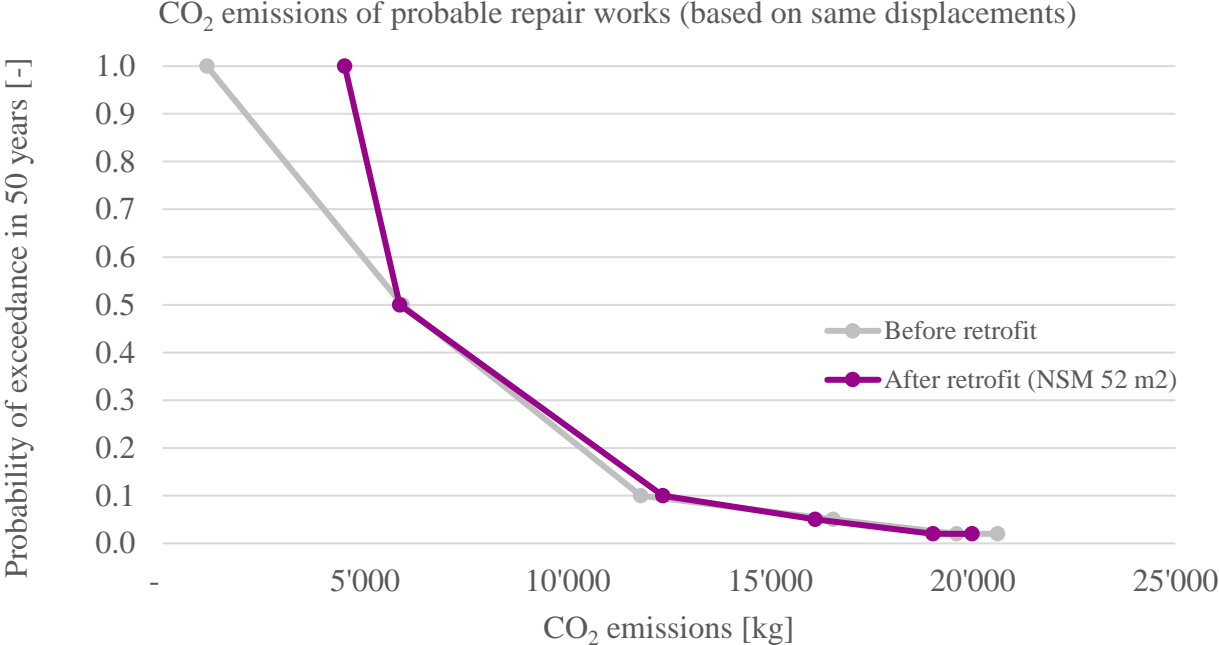
Figure 40: CO₂ emissions of probable repair works for different displacements and related probabilities of exceedance (loss functions) before retrofit and after optimised NSM steel reinforcement (area of application: 54.2 m²)

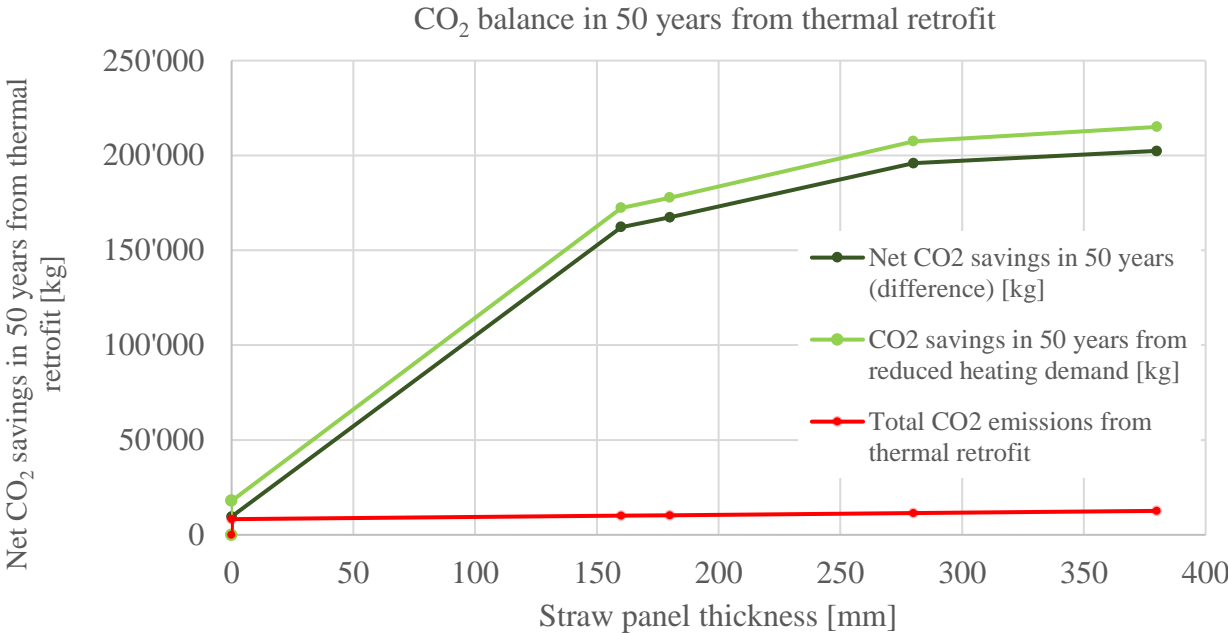
Figure 42: Net CO₂ savings from thermal interventions (savings from reduced thermal demand-investment for thermal retrofit) in function of wall insulation thickness
